# Handmade Clay Plain Tiles including Peg Tiles Heritage Directory Note

Copyright The Heritage Directory 2010 v1

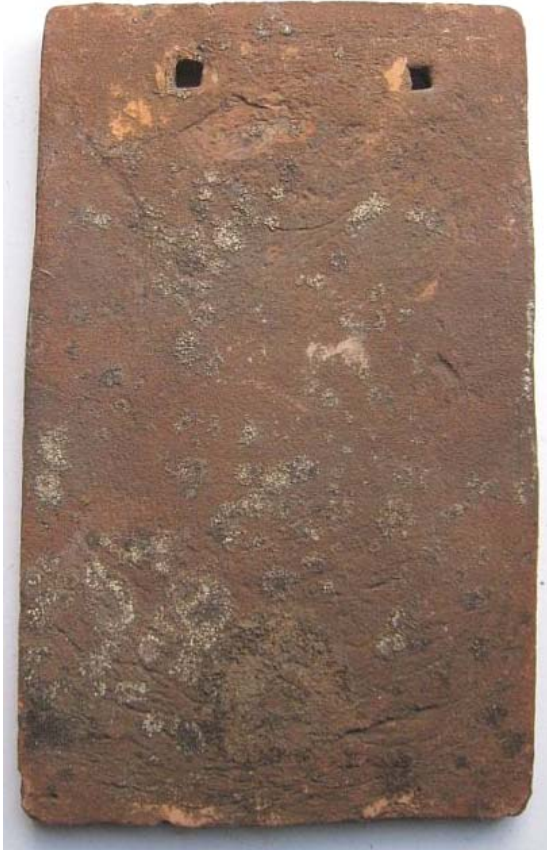
This Peg Tile is of a type historically used widely across the country and is larger than than the Kent Peg.

The peg was traditionally of timber, one peg being inserted in one of the two holes provided. They are still available today but metal pegs are more commonly used now. Most peg tiles measure around 265 by 160 mm, fairly much in line with the Statute of 1477. A half an inch smaller version is used in Kent, perhaps influenced by smaller tiles found in Normandy. Secondhand tiles can vary as much as inch in dimension.

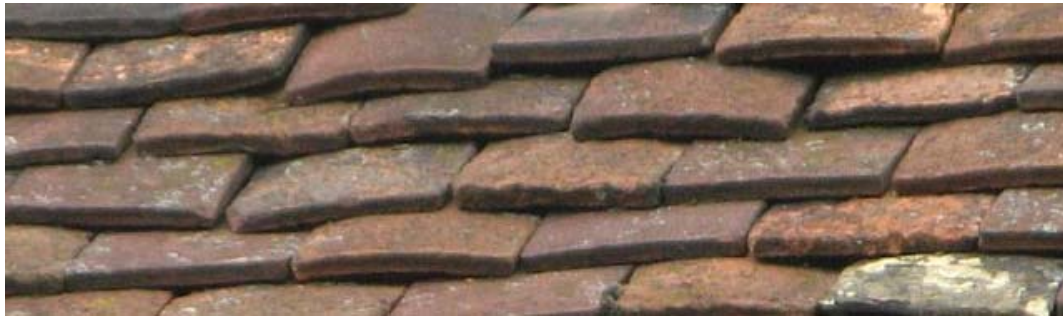
(Above) Some of these second peg tiles show the camber which adds character to a roof

A steep pitched roof, traditionally 48 degrees, but usually at least 45 degrees is used. Second hand tiles have historically have been used and it is important that when reroofing as many tiles are reused as possible, as they are important for showing local character and history due to variants in production. Too often tiles that have been used on a site for centuries are lost in reproofing. Cambered tiles, particularly across the face of the tile, give a roof much character. The use of riven lathes also add to the irregular and picturesque appearance.

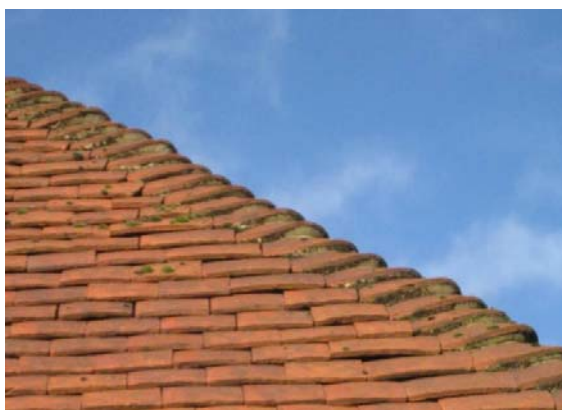
Bonnet tiles have been used for centuries for roof hips.

Bonnet tiles have traditionally been used on hips. Traditional third round or hogsback ridge tiles also sit closer to the roof than half round tiles. Sprockets provide a kick at the eaves and provided a means of disposing of water before guttering. In the early 20<sup>th</sup> century swept and laced valley gutters became popular on arts and crafts houses. Upturns to the ridge and eaves ends also were employed. Decorative tiles have existed since the twelfth century, with corners chamfered with a straight or curved line. Diamond cut tiles are also an old pattern. Tiles cut in half at verges are a traditional detail and visually are more suitable than the Victorian tile and a half, but need care to ensure they are securely fixed.

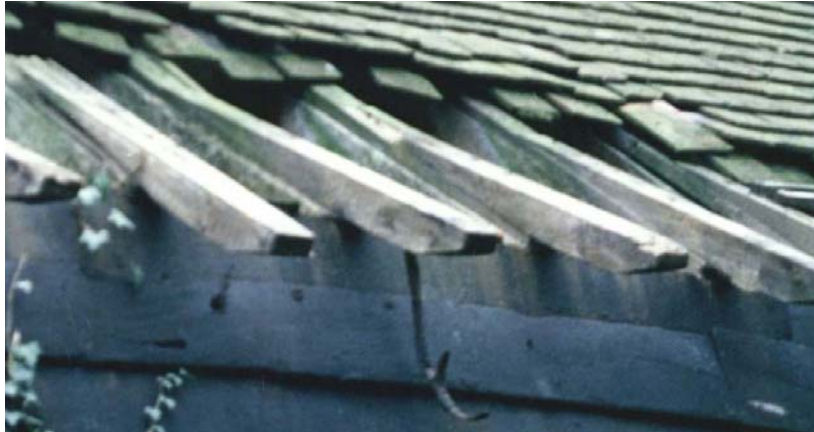
The decay of this clay tiles has revealed the added sprockets, which provide a kick at the eaves to direct water off a roof and away from the walls.

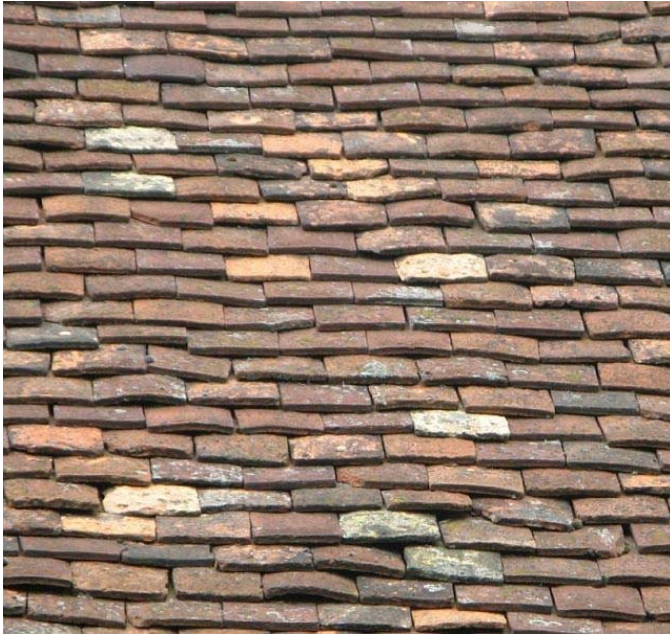
**A second hand peg tile roof in the South East, showing the variety and age of tiles which might occur including yellow gault tile.**

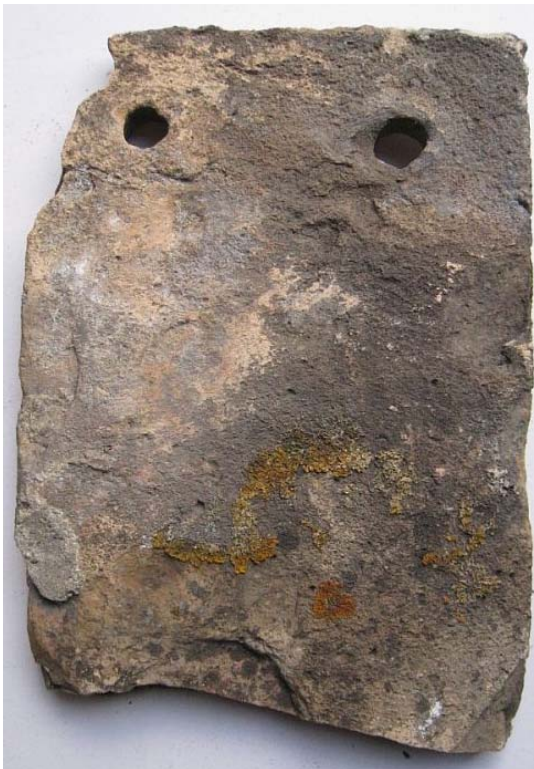
**A yellow gault clay tile, in use until recently broken, probably several hundred years old.**
